Case Study: Mount Edgecombe Interchange – investigation, design and construction of a complex geotechnical project

F.P. Pequenino, F.H. van der Merwe & C. Purchase
previously at SMEC South Africa (Pty) Ltd, Johannesburg, South Africa

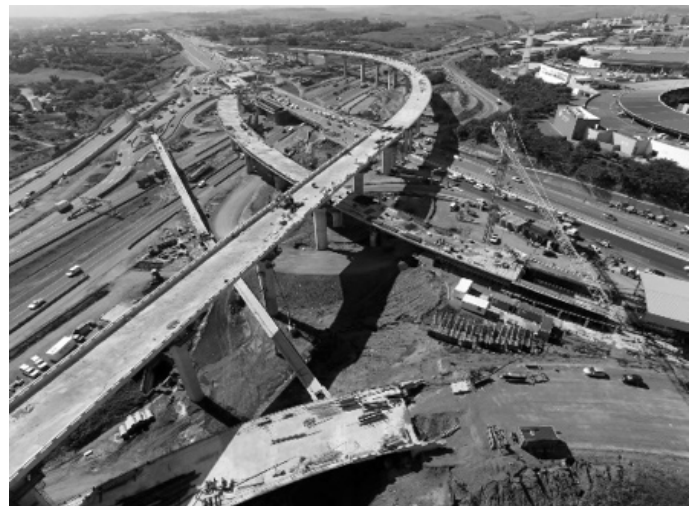
Figure 1. Aerial photo of Mt Edgecombe Interchange in March 2017 with the free flow upper level ramp in centre (SANRAL).

The upgrade included six new and four upgraded bridge structures, of which the main feature was the two free flow upper level ramp viaducts of 443 and 947 metre length. The latter is the longest incrementally launched bridge in South Africa and was incrementally launched from the opposite abutment ends, and designed to be stitched in the centre (Concrete Society of Southern Africa, 2018).

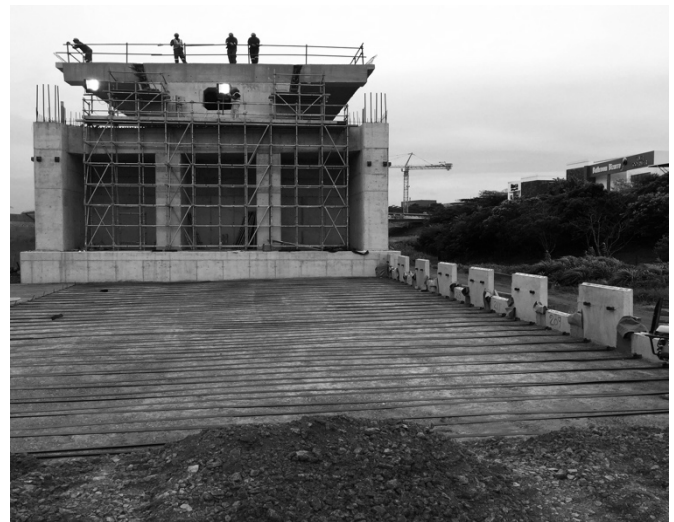
Figure 3. Back-to-back MSEW at one of the Viaduct Abutments

Mechanically Stabilised Earth Walls (MSEW) were utilised for a number of the approach ramps as a result of economic considerations and space constraints. There were nine MSEW varying from 3 to 16m high, with four of the largest walls constructed as back to back. At 16m high, these are some of the highest walls in South Africa and presented the designers with some unique challenges (Purchase and Van der Merwe, 2017). The first being geotechnical and the second contractual.

As a result of the poor geotechnical conditions, high fills like these on small footprints are at high risk of excessive settlement. The main concern with the settlement is the fact these fills are the approaches to the two highest viaducts and differential settlement between the structure and the approach could result in transfer of loads to the bridge which would have catastrophic consequences. To solve this problem the insitu founding material would have to be significantly improved prior to constructing the high fills and bridge abutments. The improvement was done by means of Dynamic Compaction (DC) and the installation of Dynamic Replacement Stone Columns (SC).
